43, High Street
Deanshanger
MILTON KEYNES
MK19 6HD

about your new home

Report Reference No: 1306714

Date: 14 August 2009

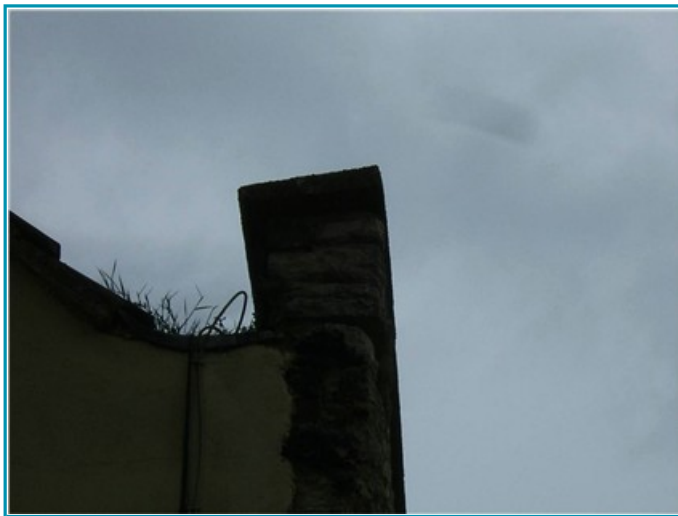
<p>D3. Rainwater pipes & gutters</p>	<p>The rainwater fittings are predominately a mixture of metal and plastic sections. However, the gutter at the back is made from a possible asbestos containing material.</p> <p>A plastic gutter along the east side of the house collects water from three of the four roof slopes. Water collected from the whole of the roof is discharged to a single downpipe.</p> <p>During heavy rainfall the gutters are unable to cope with the runoff from the roof slopes, and they overflow down the east wall of the house. The rainwater gutters are clearly not of adequate capacity. The parapet gutter is partially obstructed by vegetation.</p> <p>This is considered serious and in need of urgent repair or replacement.</p>	<p>3</p>
--	---	----------

Blocked gutter behind parapet wall at front of property

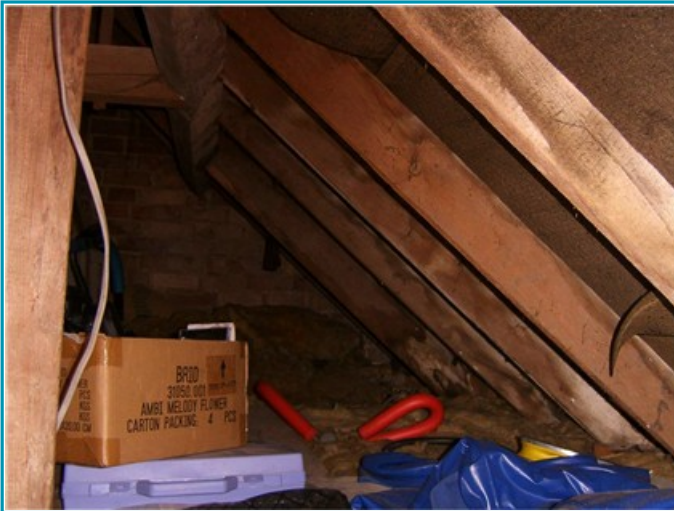
Roof space

Description and Justification for Rating and any comments	Condition Rating
<p>E1. Roof structure</p>	<p>The main roof and the extension roof are constructed using individual timbers in a traditional manner. The main roof is adequately braced. There is an access hatch to each of the two roof voids. The areas close to the eaves of the roof and the gutters are not readily accessible.</p> <p>The structure of the original main roof is satisfactory. The timber rafters of the roof over the extension are not adequately restrained at the eaves of the roof. There is a risk of spreading of the roof, though it is currently stable.</p> <p>Isolated evidence of woodboring insect infestation was noted in the roof timbers. This has not been sufficient to cause weakening of the roof structure, and can be easily eradicated by chemical treatment.</p> <p>Some repairs or replacements are required but these are not considered serious or urgent.</p>	<p>2</p>

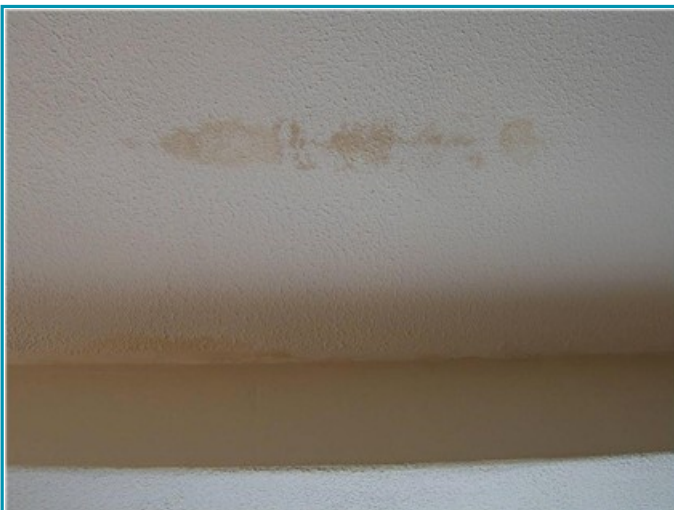
<p>E2. Ceilings</p>	<p>The ceilings are constructed from plasterboard. In some areas the original lath and plaster ceilings have been overlaid.</p> <p>A textured finish is provided to most of the ceilings. This finish may contain traces of asbestos. Please also see Section C and the appendix on Asbestos In The Home at the end of the report.</p> <p>There are minor cracks in some of the ceilings, but their general condition is consistent with their age.</p> <p>Penetrating dampness has caused staining of the ceiling in the area beneath the slipped roof tile. Please also see Section D2 which deals with this defect.</p> <p>Normal maintenance must be undertaken. No repair is presently required.</p>	<p>1</p>
----------------------------	---	----------

Damp on dining room ceiling

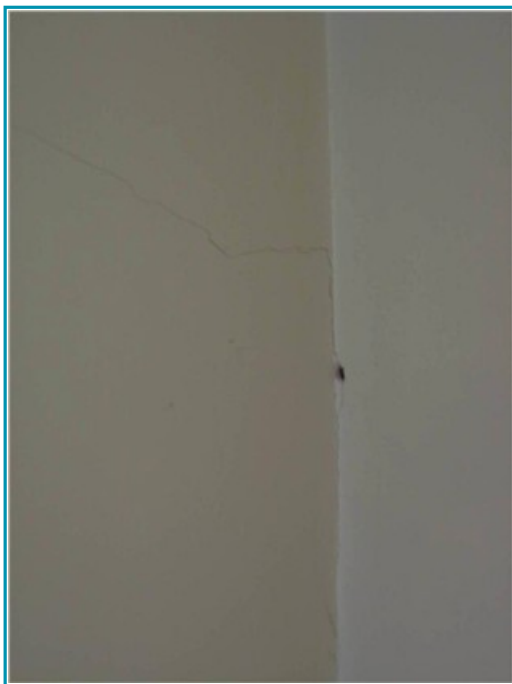
<p>E3. Inside walls, partitions & plasterwork</p>	<p>The internal walls and partitions are partly of masonry and partly of timber construction. Most wall surfaces have a finish of plaster. A wall in the kitchen is of exposed stonework.</p> <p>There is visible distortion of several of the internal door frames, and there are cracks in the wall finishes above these openings. This indicates that recent movement has occurred. The internal walls are affected by rising dampness. (Please also see Section D4.) This is particularly acute in the kitchen and may in future affect the kitchen units (Please also see Section E6).</p> <p>Further advice should be obtained.</p>	<p>3</p>
--	---	----------

Cracking on internal wall

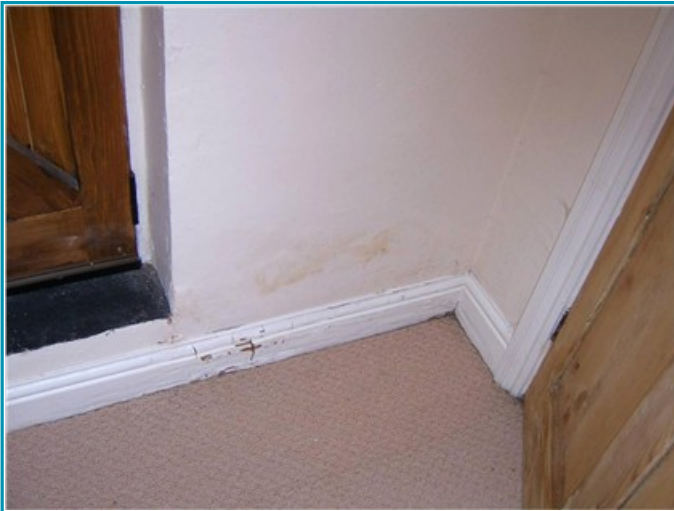
E7. Inside woodwork	<p>The internal woodwork includes such items as: doors, frames, skirting, banisters and staircases.</p> <p>The staircase is made from timber. A timber balustrade and a handrail are fitted. The internal doors are of timber.</p> <p>The staircase is steep, and the treads are narrow. Please also see Section C.</p> <p>There is a part glazed internal door which is not fitted with toughened safety glass. Please also see Section C. Some of the doors have missing knobs, and several have split panels. Several of the doors are a poor fit in their frames.</p> <p>A section of the timber skirting in the rear reception room is damaged by rot, caused by the absorption of moisture from the wall which is affected by rising dampness. Some repairs or replacements are required but these are not considered serious or urgent. (Please see also Section D4)</p>	<p>2</p>
------------------------------------	---	----------

Rot in skirting board in rear reception room

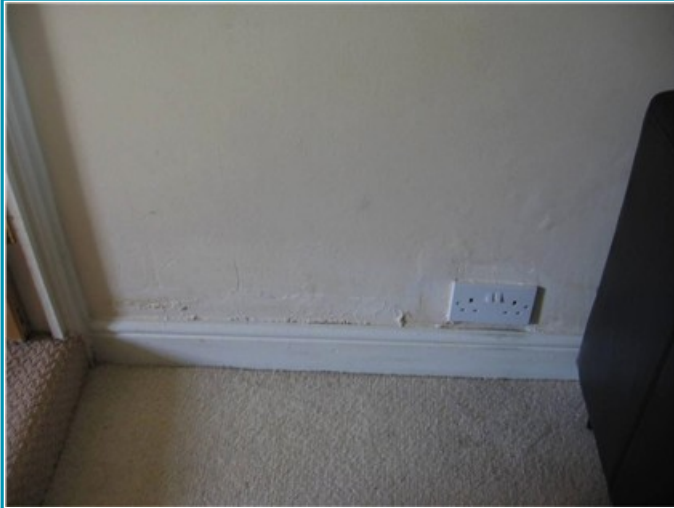
Description and Justification for Rating and any comments	Condition Rating
F1. Electricity	<p>There is an underground electrical supply and the meter is located in a cupboard in the hallway.</p> <p>There is evidence of partial replacement of sockets in the front reception rooms suggesting that the installation is not to current standards. This is potentially serious and in need of further investigations with the possible requirement for urgent repair or replacement.</p>	3

Replaced electric socket
